Understanding Evaporation: Why Don't Leaks Always Appear on my Thermal Images?

By Terry Carson, B.Sc., MBA, B.S.S.O., R.H.I., C. Tech.

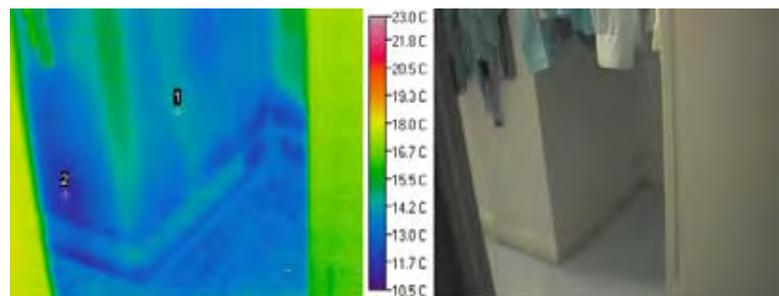
CASE 1 – CONDOMINIUM APARTMENT LEAK

This first case shows ideal conditions for evaporation and good thermal images. Water from a burst pipe migrated to a number of apartment suites below. The leak occurred 48 hours before my visit and restoration crews had vacuumed up water the previous day, and installed air movers and dehumidifiers.

The thermal image shows water-saturated wall and carpet finishes in a bedroom closet. The dark blue patterns indicate where water appears to have wicked up the wall and where the carpet was wet. Moisture meter readings confirmed thermal image results.

1. The wall assembly consisted of drywall on steel frame studs. There was no insulation or wood studs to absorb or store excess water. The drywall was porous and had considerable surface area where evaporation could take place on both sides of the wall cavity. For this reason, water restoration technicians will often create ventilation holes in wall cavities to speed up drying inside wet wall and ceiling cavities.
2. The air movers and dehumidifiers created ideal drying conditions. Ambient conditions were 19°C with a low relative humidity (RH) of 22 percent (compared to a typical interior 40 percent RH in winter), resulting in a vapour pressure decrease between the wet wall finish and ambient air of 68 percent.

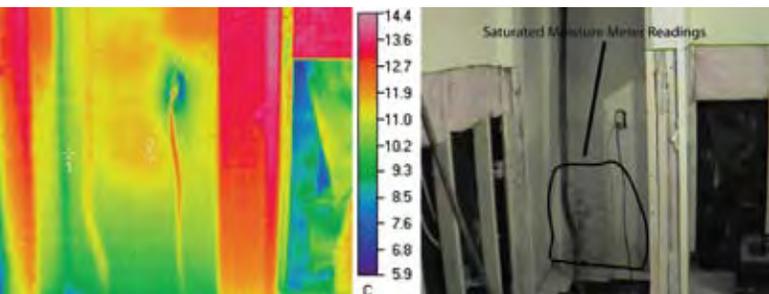
CASE 2 – BASEMENT WINTER SUMP PUMP FAILURE

Sudden freezing conditions resulted in a discharge hose obstruction, pump failure and standing water on the floor in this finished basement. The owner removed the water and lower wall drywall according to my suggestion, but not behind the sump pump. This thermal image was taken eight days later and did not pinpoint areas of saturation identified by the moisture meter, where mould was also visible. I could not determine whether the cooler temperature was moisture or simply a cooler outside wall.

1. The wall assembly consisted of a stud wall cavity on an exterior basement foundation wall. The outside temperature was well below freezing. The fiberglass insulation was acting like a sponge holding in water while the polyethylene vapour barrier was retarding evaporation, like plastic pants over a baby's wet cloth diaper.
2. The room was poorly heated and there was little air movement. The wall studs in the foreground had a temperature of only 12°C while the wet drywall surface temperature was 9°C. The vapour pressure drop between the wet wall finish and ambient air was estimated to be 21 percent, compared with 68 percent in Case 1.

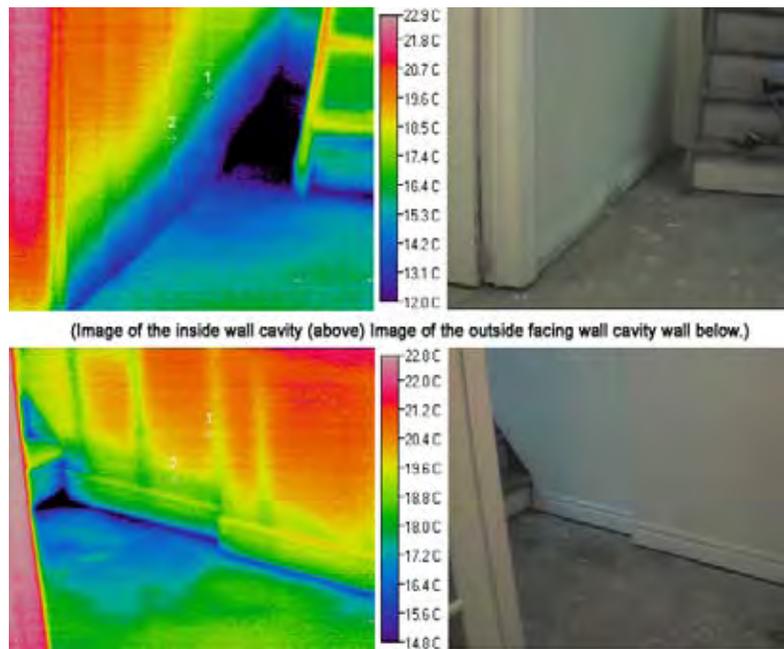
CASE 3 – OLD HOUSE BASEMENT LEAK AT BOTH EXTERIOR AND INTERIOR WALLS

3. A winter leak occurred along the back wall under the basement stairs of a 90 year old house with a stone foundation. An interior and exterior wall cavity were affected by the same leak, allowing a good comparison of evaporation of both an insulated exterior foundation wall and an interior uninsulated wall cavity. The outside wall consists of a stone foundation, wood studs, fiberglass insulation, 6 mil poly and half inch drywall. The inside partition wall consists of half inch drywall on both sides of 2x4 wood studs. The baseboard trim was removed from the interior wall. The owner in this situation installed air movers and provided heat to speed up drying.

1. It is easier to distinguish cool temperatures that result from evaporating moisture on a void interior wall cavity, than an insulated exterior wall. The reason is that the inside wall is only undergoing evaporative cooling, while the exterior wall cavity will be influenced by a number of thermal events, in addition to evaporative cooling. There will usually be cooler temperatures at the bottom due to convective air currents, conductive heat loss to the exterior, as well as air infiltration. The outline of the wall studs shows differences in thermal conductivity of wood studs and fiberglass insulation.

2. The surface temperature of the wet exterior wall surface is 18°C, compared to 15°C on the interior side. A temperature drop of two to three degrees Celcius was noted on the interior wall, as well as in Case 1, and suggests that evaporation was occurring to a greater rate at the interior wall, compared with the exterior wall. Both drywall surfaces tested as saturated with a moisture meter.

3. Remember that the blue colour on the floor and walls is cooler temperature and not water.

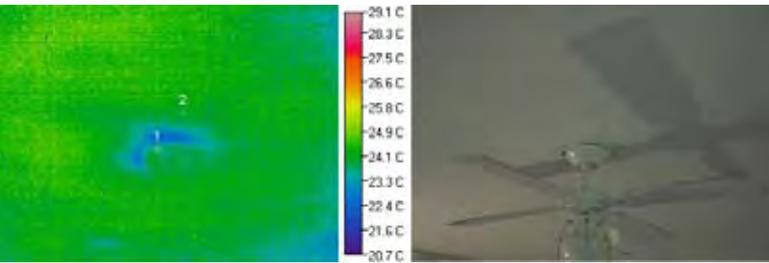
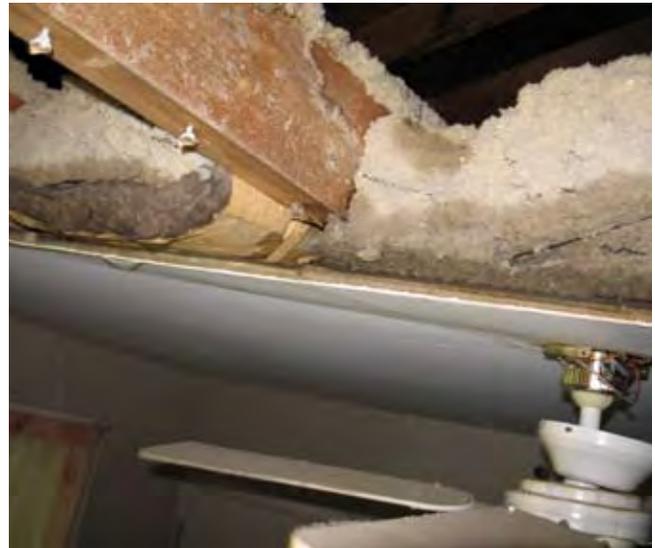
CASE 4 – SUMMER ROOF LEAK

A roofer was in a hurry and proceeded to strip the shingles from this 1955 home with 1x12 plank sheathing just before a mid-summer downpour. There was no attic access, so I had to rely on a moisture meter and my thermal imager to detect the extent of water damage. The moisture meter showed saturated ceiling moisture levels, but the thermal image suggested the moisture was limited to the area around the base of the ceiling fan. The ceiling collapsed two days later under the weight of the water soaked cellulose insulation.

approximately 1°C is difficult to note in the thermal image. Altering the level and span did not improve the image.

1. The ceilings and walls consisted of a skim coat of plaster with oil-based paint over an underlying plaster lath board, which slowed the passage of moisture. The cellulose insulation acted as a sponge soaking up excess water.
2. The indoor temperature was 25°C and the relative humidity was 63 percent, a 29 percent difference in vapour pressure, which likely resulted in some evaporation. The ceiling temperature variation (green to dark yellow range) of

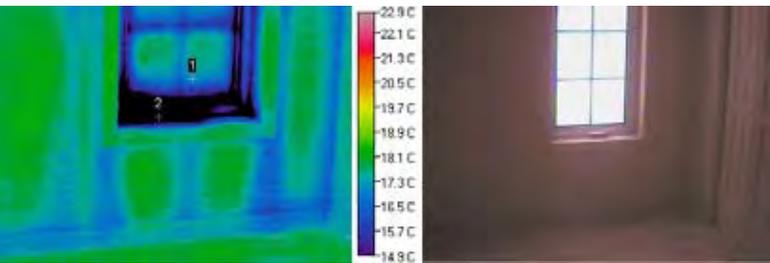
CASE 5 – LEAK IN PREFABRICATED CEILING AND WALLS

Prefabricated houses are built as complete wall and ceiling sections in a factory and are erected on site in a few days. Snow filled the insulated attic before the roof sheathing was installed, wetting the interior and some exterior wall cavities. We know there was water in the exterior wall, but was the cooler blue colour in the thermal image due to evaporation?

The visual image on the right side of the thermal image is overexposed from the sunlight shining through the window. Solar heating of the exterior wall is affecting the wall cavity and our thermal image. Thermal conductivity differences of the various materials in this wall cavity (such as wood studs and insulation), and between wet and dry insulation seem to be dominating this image. Matted insulation, voids, air leakage, other anomalies and other factors may also contribute to these temperature variations. Evaporation may be happening but is difficult to detect. This case shows the complexity of thermal events that may occur in images of above grade exterior walls. We should also remember that evaporation may occur between the interior cavity and the exterior.

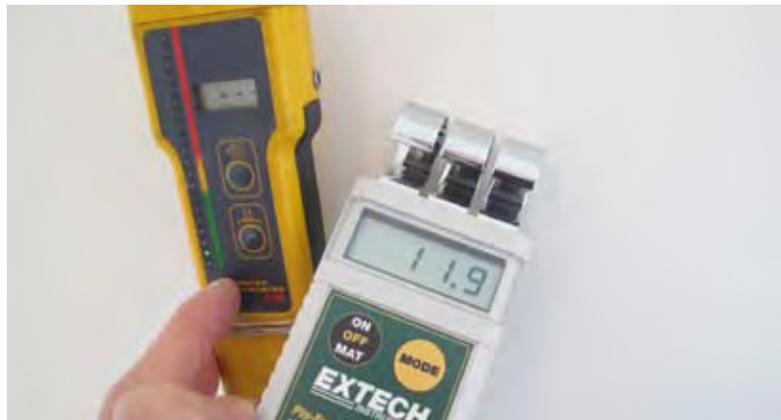
Moisture meters were placed on the wall, approximately one foot to the left of the window. The yellow moisture meter has one green light lit on the bottom of the scale, indicating no

elevated moisture. This unit only senses to ~3/4 inch depth, suggesting the drywall and insulation close to the vapour barrier was dry. The moisture meter on the right however shows 11.9 percent, which is near saturation, somewhere within 1.5 inches of the wall surface. This case demonstrates the importance of understanding the sensing range and limitations of moisture meters and the benefits of using more than one moisture meter for non-invasive moisture verification.
